**Flood Control Project Maintenance
Levee Inspections**

Maintenance Issue Types Only, Levee Inspection Report By Mile - Spring 2018

Sutter Maintenance Yard East Levee Sacramento River

Waterway	Bank	Unit Miles	Inspection Start/End	Inspector
Unit No. 01 Sacramento River	Left	19.85	04/19/2018 04/19/2018	Bob Duffey

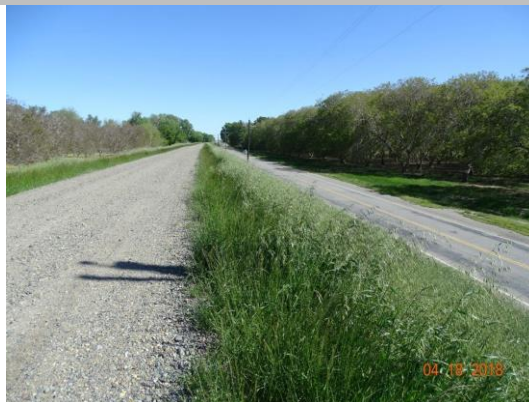
Photo 1 of 1 : SP_2018_ST0003_264_110_20180430_00196.jpg

LM Start	0.00	Rating **	M	Issue No.	110
LM End	20.30	Issue Type +	Ma	Location *	LS
Category	Earthen Levee			GPS Latitude/Longitude	
				Start	End
Item	Vegetation			39.194100 °	39.383865 °
				-121.935568 °	-121.990355 °
DWR ID	DWR_ST0003_01_s_2018_110				
Comment Code					
V1 : Control annual grass and weeds on the levee slopes and easements.					
Inspector Comment					
Remove the native vegetation from the landside slope.

View of the native vegetation along the landside slope.

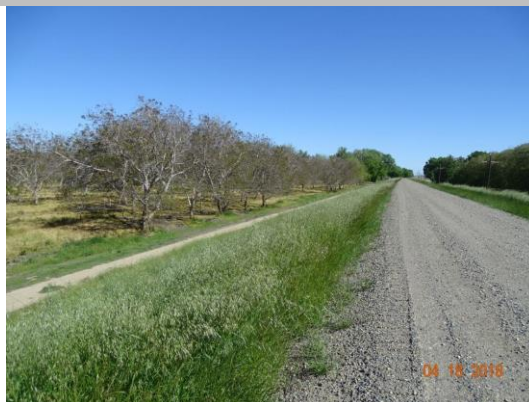
Photo 1 of 1 : SP_2018_ST0003_264_111_20180430_00197.jpg

LM Start	0.00	Rating **	M	Issue No.	111
LM End	20.30	Issue Type +	Ma	Location *	WS
Category	Earthen Levee			GPS Latitude/Longitude	
				Start	End
Item	Vegetation			39.194100 °	39.383865 °
				-121.935568 °	-121.990355 °
DWR ID	DWR_ST0003_01_s_2018_111				
Comment Code					
V1 : Control annual grass and weeds on the levee slopes and easements.					
Inspector Comment					
Remove the native vegetation from the waterside slope.

View of the native vegetation along the waterside slope.

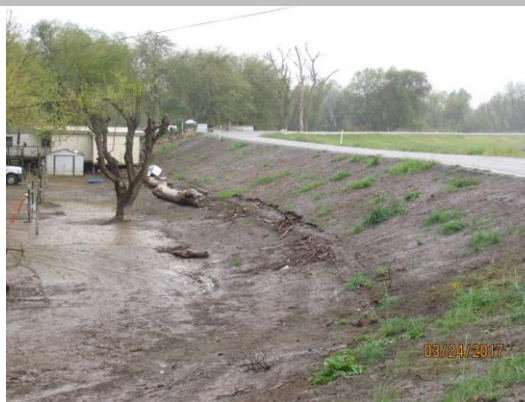
Photo 1 of 1 : SP_2018_ST0003_264_130_20180305_00029.jpg

LM Start	0.11	Rating **	M	Issue No.	130
LM End	0.14	Issue Type +	Ma	Location *	WS
Category	Earthen Levee			GPS Latitude/Longitude	
				Start	End
Item	Slope Stability			39.195163 °	39.195038 °
				-121.936815 °	-121.937435 °
DWR ID	DWR_ST0003_01_s_2017_130				
Comment Code					
S1 : Repair slope instability.					
Inspector Comment					
Repair the erosion along the waterside slope.

View of the erosion along the waterside slope.

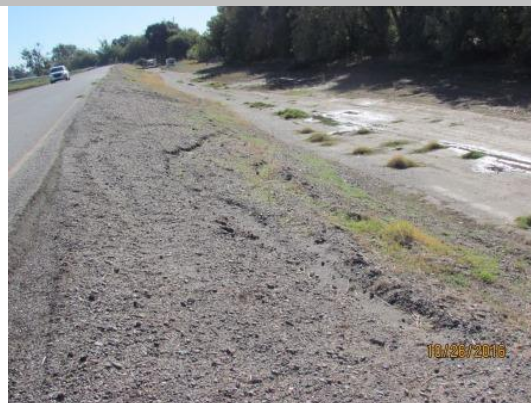
Photo 1 of 1 : SP_2018_ST0003_264_81_20180305_00022.jpg

LM Start	0.42	Rating **	M	Issue No.	81
LM End	0.42	Issue Type +	Ma	Location *	WS
Category	Earthen Levee			GPS Latitude/Longitude	
				Start	End
Item	Slope Stability			39.196483 °	39.196483 °
				-121.942228 °	-121.942228 °
DWR ID	DWR_ST0003_01_f_2016_81				
Comment Code					
S3 : Repair the levee slope damaged by vehicle traffic and prevent access where possible.					
Inspector Comment

View of the ruts along the waterside slope.

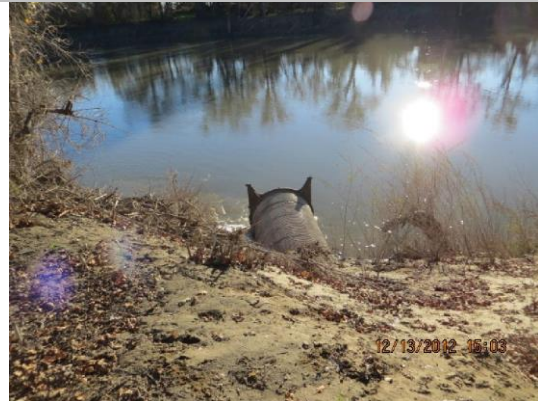
Photo 1 of 3 : UCIP_SP_2018_51650_46962.jpg

Waterside view: overview towards CMP sewer pipe

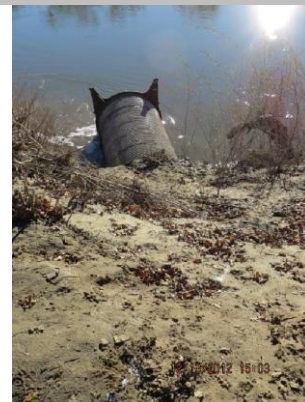
Photo 2 of 3 : UCIP_SP_2018_51650_46960.jpg

Waterside view: water flowing from CMP sewer pipe

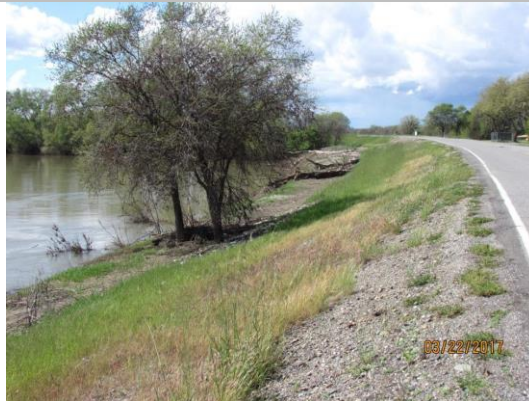
Photo 1 of 1 : SP_2018_ST0003_264_9_20180305_00008.jpg

View of the debris along the waterside slope.

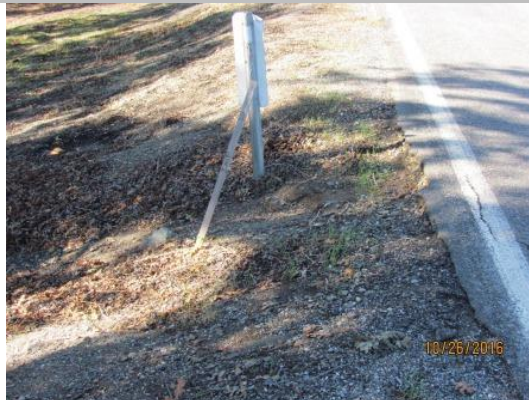
Photo 1 of 1 : SP_2018_ST0003_264_80_20180305_00021.jpg

LM Start	1.17	Rating **	M	Issue No.	80
LM End	1.17	Issue Type +	Ma	Location *	WS
Category	Earthen Levee			GPS Latitude/Longitude	
				Start	End
Item	Slope Stability			39.194126 °	39.194126 °
				-121.953345 °	-121.953345 °
DWR ID	DWR_ST0003_01_f_2016_80				
Comment Code					
S1 : Repair slope instability.					
Inspector Comment

View of the slope instability along the waterside slope.

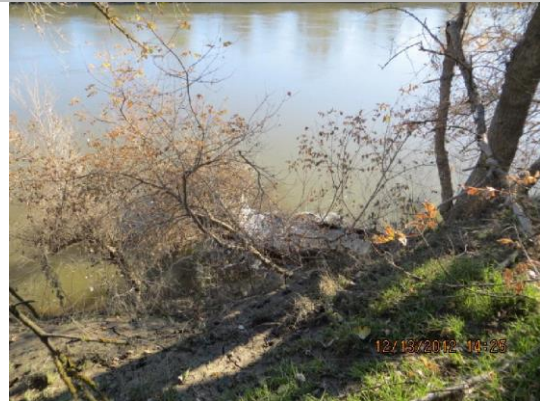
Photo 1 of 3 : UCIP_SP_2018_51655_46992.jpg

FS_ID:51655
DS_ID:17320
EP_NO: 9543
Repair Type: Urgent
Crossing Status: Found
UCIP Comments: 4/24/2017 WS was underwater during the site visit but I do not believe that any repairs have been made to this crossing yet. (DWR Sutter Yard- AFreitag)11/7/2016 No repairs have been made here yet. (DWR Sutter Yard- AFreitag)6/17/2016 River levels were down and the WS pipe end was exposed. WS end is completely rotten and damaged and flap gate has fallen off the end of the pipe (see pics). Pipe needs to be replaced or repaired. (DWR Sutter Yard - afreitag)4/5/2016 Erosion on WS slope still present. Pipe still fully submerged on WS and discharging into river during site visit. (DWR UCIP - kfazel)4/6/2015 Pipe leaks during high water. DWR employee said he suspects that the flap gate has rotted and fallen off WS end of pipe. Could not locate WS end of pipe to confirm. Water was flowing through this drain during field survey. (DWR Sutter Yard - afreitag)6/30/2014 Same as last inspection. (DWR Sutter Yard - afreitag)12/30/2013 Same as last inspection. (DWR Sutter Yard - afreitag)7/29/2013 Same as last inspection. (DWR Sutter Yard - afreitag) 12/13/2012 Water was flowing through this drain during field survey. (DWR UCIP - pamatya)

Waterside view: overview of river bank

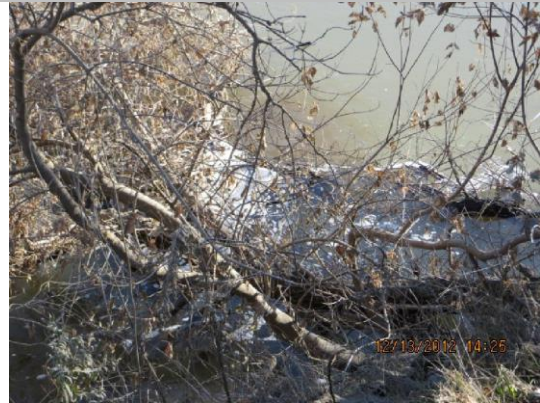
Photo 2 of 3 : UCIP_SP_2018_51655_46991.jpg

UCIP Comments: 4/24/2017 WS was underwater during the site visit but I do not believe that any repairs have been made to this crossing yet. (DWR Sutter Yard- AFreitag)11/7/2016 No repairs have been made here yet. (DWR Sutter Yard- AFreitag)6/17/2016 River levels were down and the WS pipe end was exposed. WS end is completely rotten and damaged and flap gate has fallen off the end of the pipe (see pics). Pipe needs to be replaced or repaired. (DWR Sutter Yard - afreitag)4/5/2016 Erosion on WS slope still present. Pipe still fully submerged on WS and discharging into river during site visit. (DWR UCIP - kfazel)4/6/2015 Pipe leaks during high water. DWR employee said he suspects that the flap gate has rotted and fallen off WS end of pipe. Could not locate WS end of pipe to confirm. Water was flowing through this drain during field survey. (DWR Sutter Yard - afreitag)6/30/2014 Same as last inspection. (DWR Sutter Yard - afreitag)12/30/2013 Same as last inspection. (DWR Sutter Yard - afreitag)7/29/2013 Same as last inspection. (DWR Sutter Yard - afreitag) 12/13/2012 Water was flowing through this drain during field survey. (DWR UCIP - pamatya)

Waterside view: water flowing from outlet pipe (pipe fully submerged)

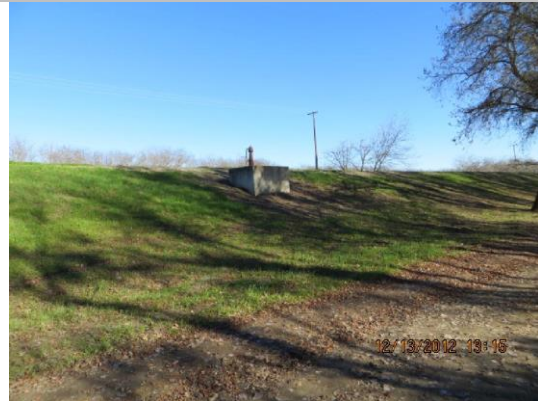
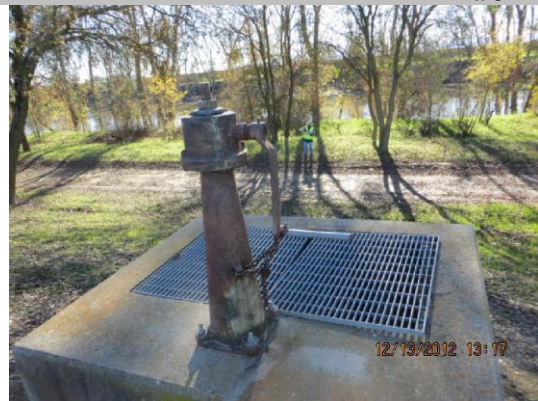
FS_ID:51660
DS_ID:17309
EP_NO: 9541
Repair Type: Non-Urgent
Crossing Status: Found
UCIP Comments: 4/24/2017 Still no sign of WS pipe end or flapgate.
LS appears to be in good condition. (DWR Sutter Yard- AFreitag)

Waterside view: overview- concrete surg tank

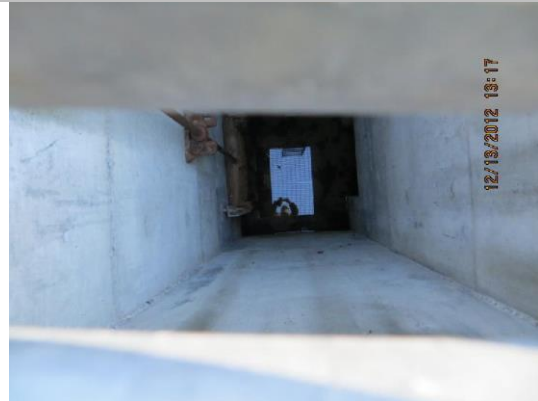
Photo 3 of 3 : UCIP_SP_2018_51660_47025.jpg

Waterside view: slide gate inside concrete surg tank

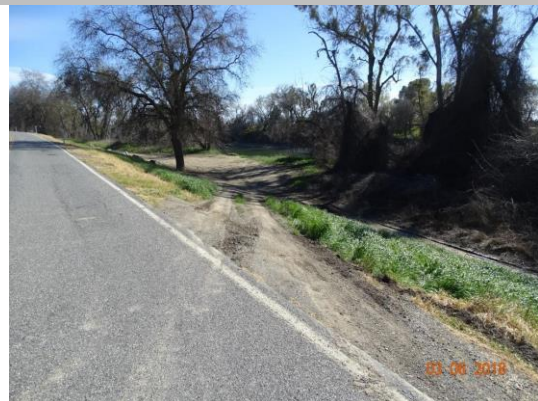
Photo 1 of 1 : SP_2018_ST0003_264_104_20180312_00185.jpg

LM Start	2.84	Rating **	M	Issue No.	104
LM End	2.84	Issue Type +	Ma	Location *	WS
Category	Earthen Levee			GPS Latitude/Longitude	
				Start	End
Item	Slope Stability			39.191162 °	39.191162 °
				-121.980365 °	-121.980365 °
DWR ID	DWR_ST0003_01_s_2018_104				
Comment Code					
S3 : Repair the levee slope damaged by vehicle traffic and prevent access where possible.					
Inspector Comment					
Repair the erosion along the water side slope caused by vehicle traffic.

View of the erosion along the waterside slope caused by vehicle traffic.

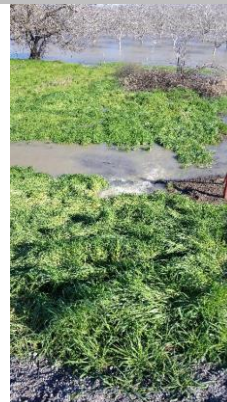
Photo 2 of 3 : UCIP_SP_2018_51665_76920.jpg

FS_ID:51665
DS_ID:17311
EP_NO: N/A
Repair Type: Urgent
Crossing Status: Found
UCIP Comments: 4/6/2017 Pipe was found in January 2017 during a high water event when water uncovered the buried WS end which led to uncontrolled water flow through during the high water event. The WS pipe opening was temporarily blocked off by plywood and sandbags until the pipe can be properly plugged or abandoned. Pics updated. (DWR Sutter Yard- A Freitag) 11/7/2016 Unable to locate. (DWR Sutter Yard- A Freitag) 6/6/2016 Unable to locate. 4/6/2015 Unable to locate. 6/30/2014 Unable to locate. 12/30/2013 Unable to locate. 7/29/2013 Same as last inspection. Unable to locate.
FIELD_STRUCT_DESC: *ABANDONED* 24-inch corrugated metal drainage pipe through the levee, 12.4 feet below the crown. Slide gate on the waterside (WS) end. Pipe silted over on both ends. (Automatic Board Order (ABO) issued as Permit No. 9539, 1974 - Locvich).

LS view from levee shoulder

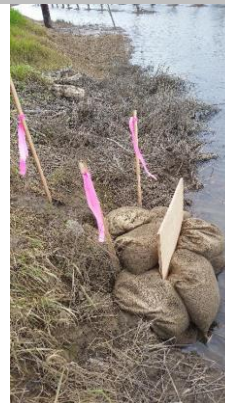
Photo 3 of 3 : UCIP_SP_2018_51665_76921.jpg

WS view of the temporary plug on WS end.

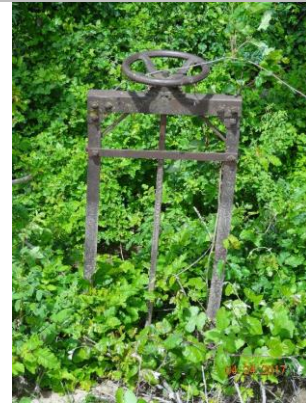
Photo 1 of 2 : UCIP_SP_2018_51666_77004.jpg

FS_ID:51666
DS_ID:17313
EP_NO: N/A
Repair Type: Non-Urgent
Crossing Status: Found
UCIP Comments: 4/24/2017 Slide gate structure found on WS about 10ft from levee toe. Vegetation was too thick to see if there were any more appurtances associated with this crossing visible on the WS. Nothing was visible on the LS. House located above pipe alignment at LS levee toe. Crossing appears abandoned and should be done so properly. (DWR Sutter Yard- A Freitag)11/7/2016 Unable to locate. (DWR Sutter Yard- A Freitag)6/6/2016 Unable to locate.4/6/2015 Unable to locate.6/30/2014 Unable to locate.12/30/2013 Unable to locate.7/29/2013 Same as last inspection. Unable to locate.
FIELD_STRUCT_DESC: *ABANDONED* 18-inch corrugated metal drainage pipe through the levee, 15 feet below the crown. Slide gate on the waterside (WS) end. [Additional Reference(s): DWR Levee Log, 2002. USACE Sacramento O&M Manual 136, March 1960 (HLM 3.6)].

Slide gate structure found on WS

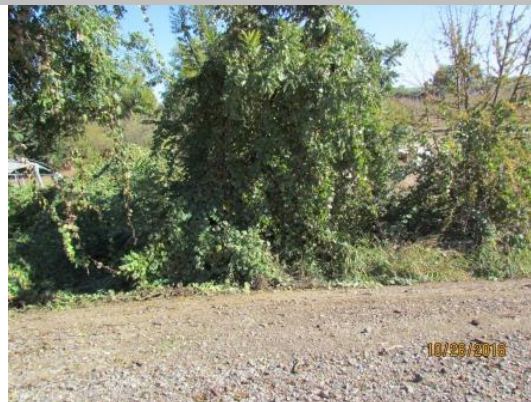
Photo 1 of 1 : SP_2018_ST0003_264_99_20180305_00026.jpg

View of the overgrown vegetation along the landside slope.

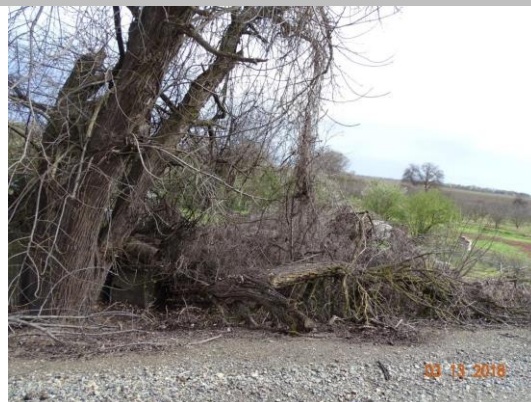
Photo 1 of 1 : SP_2018_ST0003_264_106_20180402_00187.jpg

LM Start	6.47	Rating **	M	Issue No.	106
LM End	6.47	Issue Type +	Ma	Location *	LS
Category	Earthen Levee			GPS Latitude/Longitude	
				Start	End
Item	Encroachments			39.224812 °	39.224812 °
				-121.998615 °	-121.998615 °
DWR ID	DWR_ST0003_01_s_2018_106				
Comment Code					
TR : Tree or limb					
Inspector Comment					
Remove the down tree from the landside slope.

View of the downed tree along the landside slope.

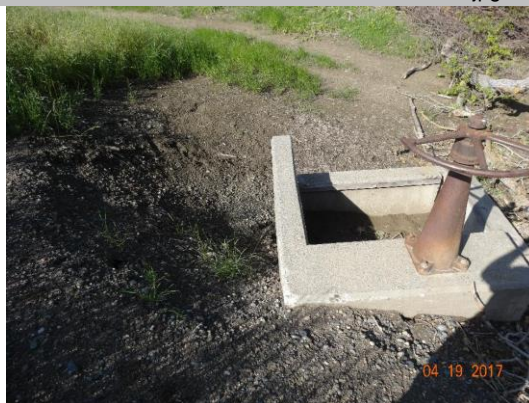
Photo 1 of 3 : UCIP_SP_2018_51695_77008.jpg

Comment Code						
Inspector Comment						
FS_ID:51695 DS_ID:17301 EP_NO: 9532 Repair Type: Non-Urgent Crossing Status: Found UCIP Comments: 4/19/2017 Abandoned- erosion/depression present around the WS box (DWR Sutter Yard- AFreitag)10/31/2016 Abandoned and erosion still present near WS box.(DWR Sutter Yard-Afreitag)6/1/2016 Appears to be an abandoned crossing.4/1/2015 Silted concrete box on WS. Depression/erosion around concrete box on WS.Silted concrete box on WS. Depression/erosion around concrete box on WS.6/30/2014 Same as last inspection.12/18/2013 Same as last inspection.7/23/2013 Same as last inspection. FIELD_STRUCT_DESC: *ABANDONED* 36-inch by 48-inch reinforced concrete box drainage culvert through the levee, 11.6 feet below the crown. Slide gate in a concrete box on the waterside (WS) slope. (3-foot by 4-foot culvert [HLM 7.73] authorized under Automatic Board Order (ABO) issued as Permit No. 9532, 1974 - Martin). [Additional Reference(s): DWR Levee Log, 2002. USACE Sacramento O&M Manual 136, March 1960 (HLM 7.73)]. FS Date: 4/26/2017 2:38:29 PM

Depression around WS concrete box

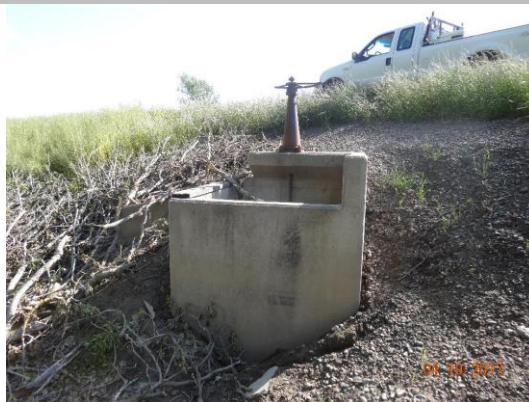
Photo 2 of 3 : UCIP_SP_2018_51695_77009.jpg

depression around WS concrete box

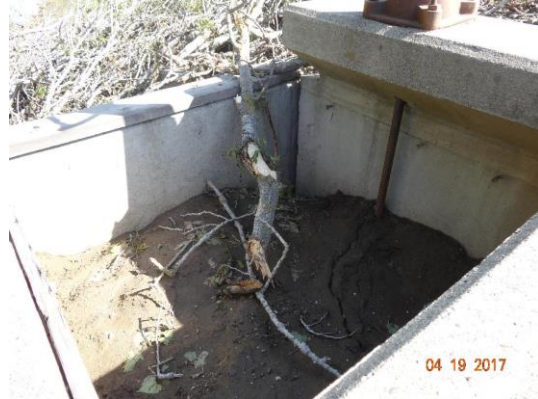
Photo 3 of 3 : UCIP_SP_2018_51695_77010.jpg

WS concrete box full of silt.

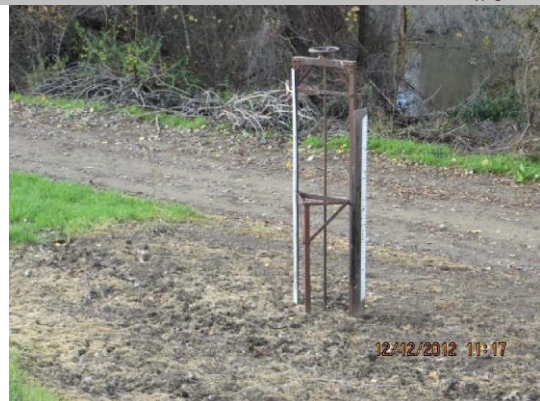
Photo 2 of 3 : UCIP_SP_2018_51726_47209.jpg

Waterside view: buried slide gate

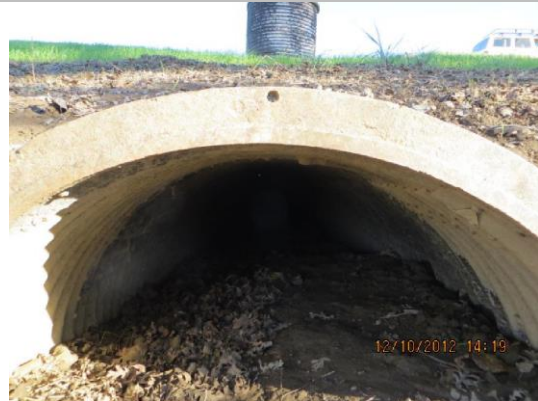
Photo 3 of 3 : UCIP_SP_2018_51749_47341.jpg

Waterside view: silted concrete lined CMP outlet pipe

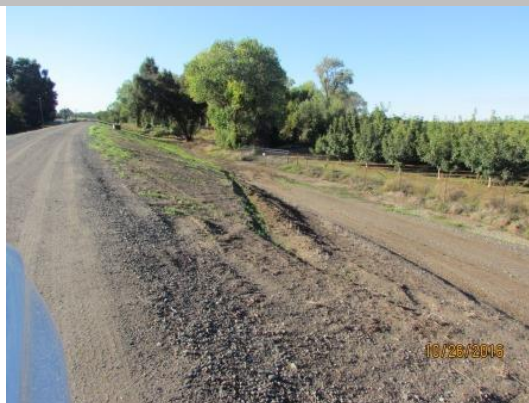
Photo 1 of 1 : SP_2018_ST0003_264_75_20180305_00018.jpg

View of the slope instability along the waterside slope.

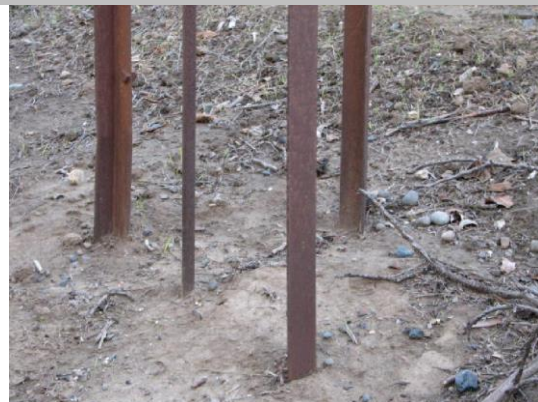
Photo 3 of 3 : UCIP_SP_2018_51762_47385.jpg

Waterside view: burried slide gate

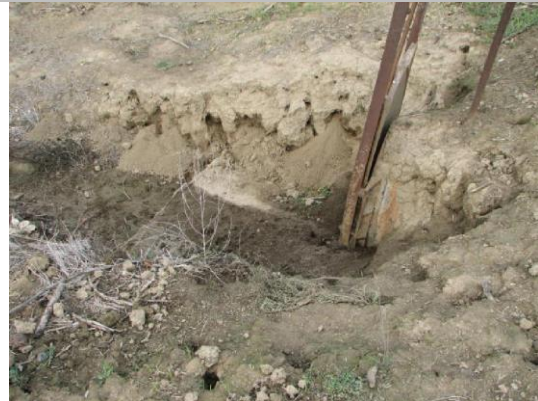
Photo 3 of 3 : UCIP_SP_2018_51770_47403.jpg

Waterside view: sloughing at outlet pipe

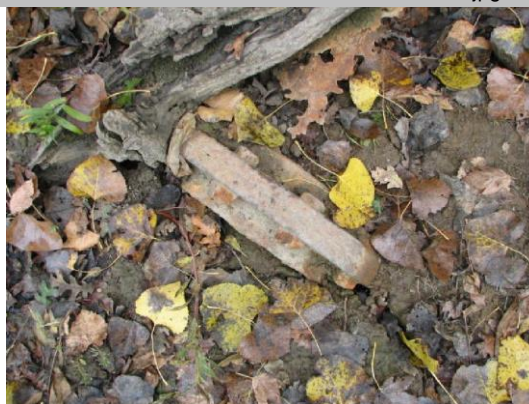
Photo 2 of 3 : UCIP_SP_2018_51775_47448.jpg

Waterside view: abandoned and ruined pipe

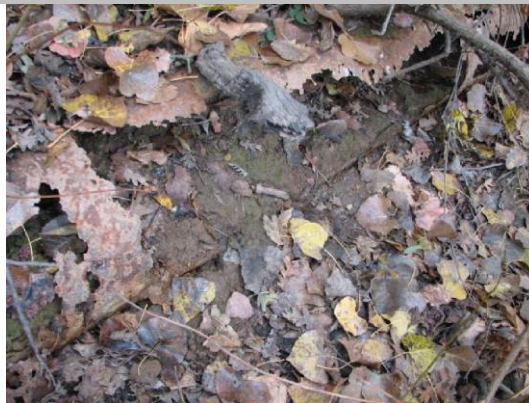
Photo 3 of 3 : UCIP_SP_2018_51775_47453.jpg

Waterside view: abandoned and ruined pipe

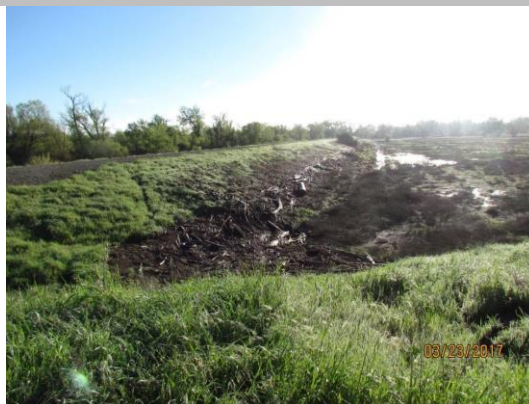
Photo 1 of 1 : SP_2018_ST0003_266_11_20180305_00004.jpg

View of the debris along the waterside slope and toe.

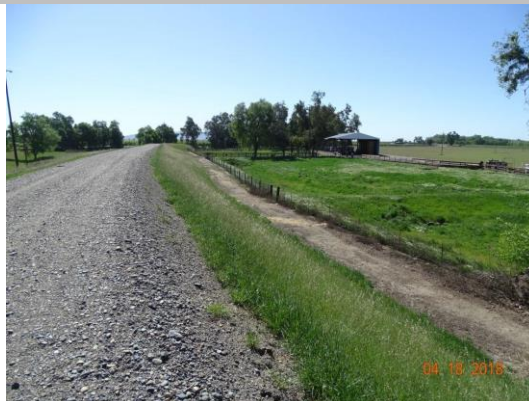
Photo 1 of 1 : SP_2018_ST0003_267_2_20180430_00001.jpg

View of the native vegetation along the landside slope.
